ESP Guardian Shield™

Case Study

Well Performance Before & After OSI's BHA Design

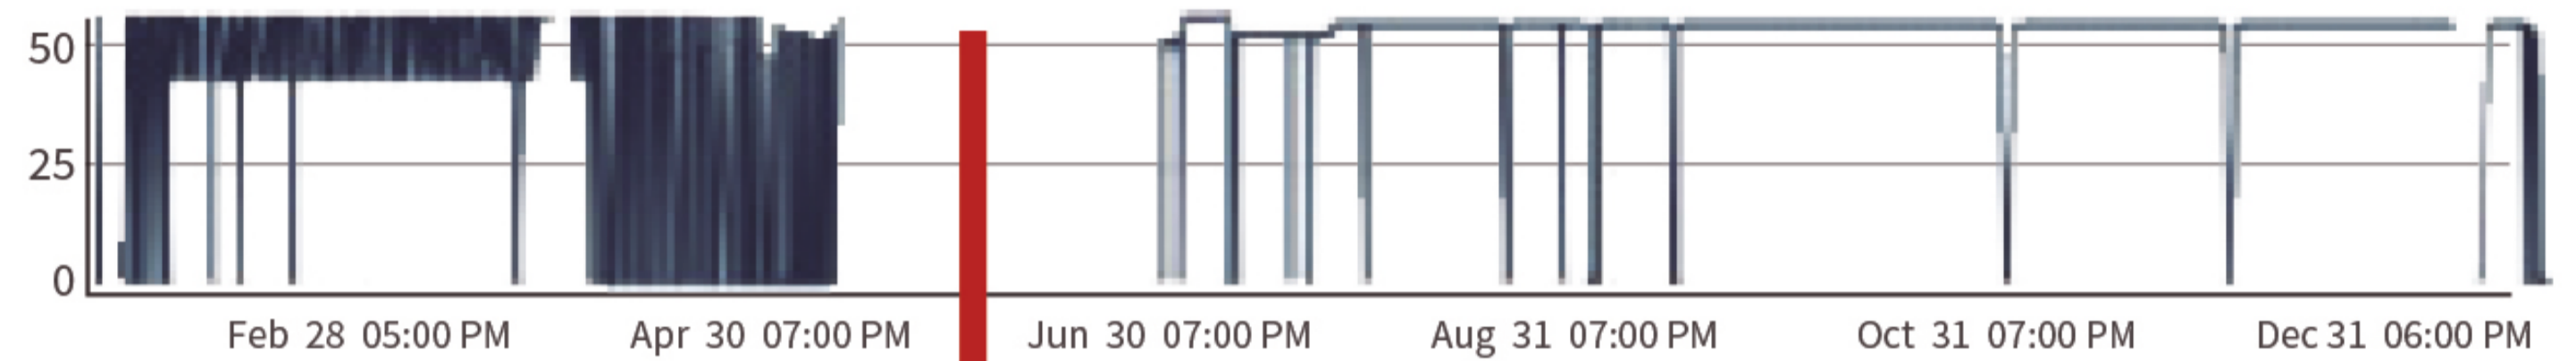
Motor Frequency

56.00 4:01 pm
hz

∨ 0.00 ∨ 65.00 ∨ 65.00 ∨ 47.76

- Average motor temperature and Fluid temperature almost dropped by 100° F. Average motor temperature dropped from 182.3° F to 139.3° F after OSI's tool installation
- The difference between motor temperature and fluid temperature is 2° F indicating high gas separation efficiency with negligible free gas presence
- Along with that, the fluctuations in the temperature has reduced and become constant which hadn't been observed before
- Motor frequency remained stable which prevented ESP shutdowns, increasing the pump efficiency

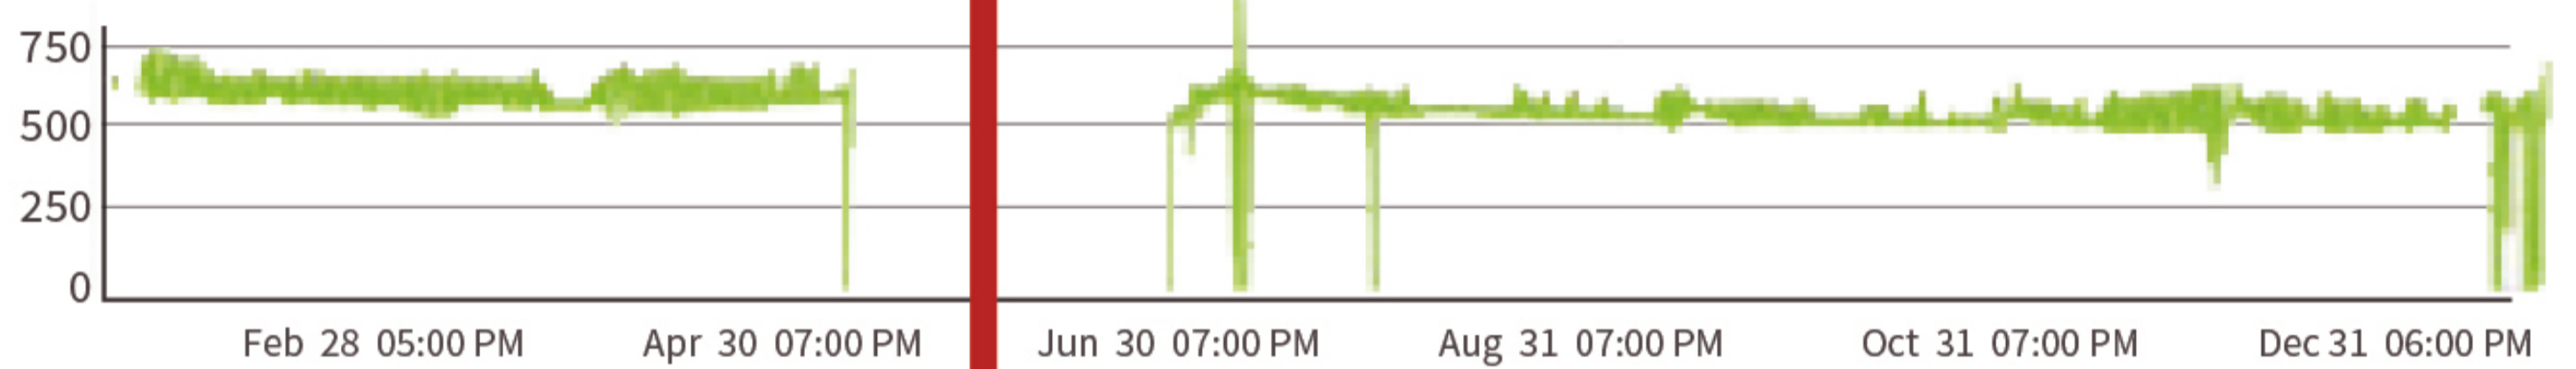
Pump Intake

549.1 4:01 pm
psi

∨ 0.0 ∨ 915.6 ∨ 915.6 ∨ 596.3

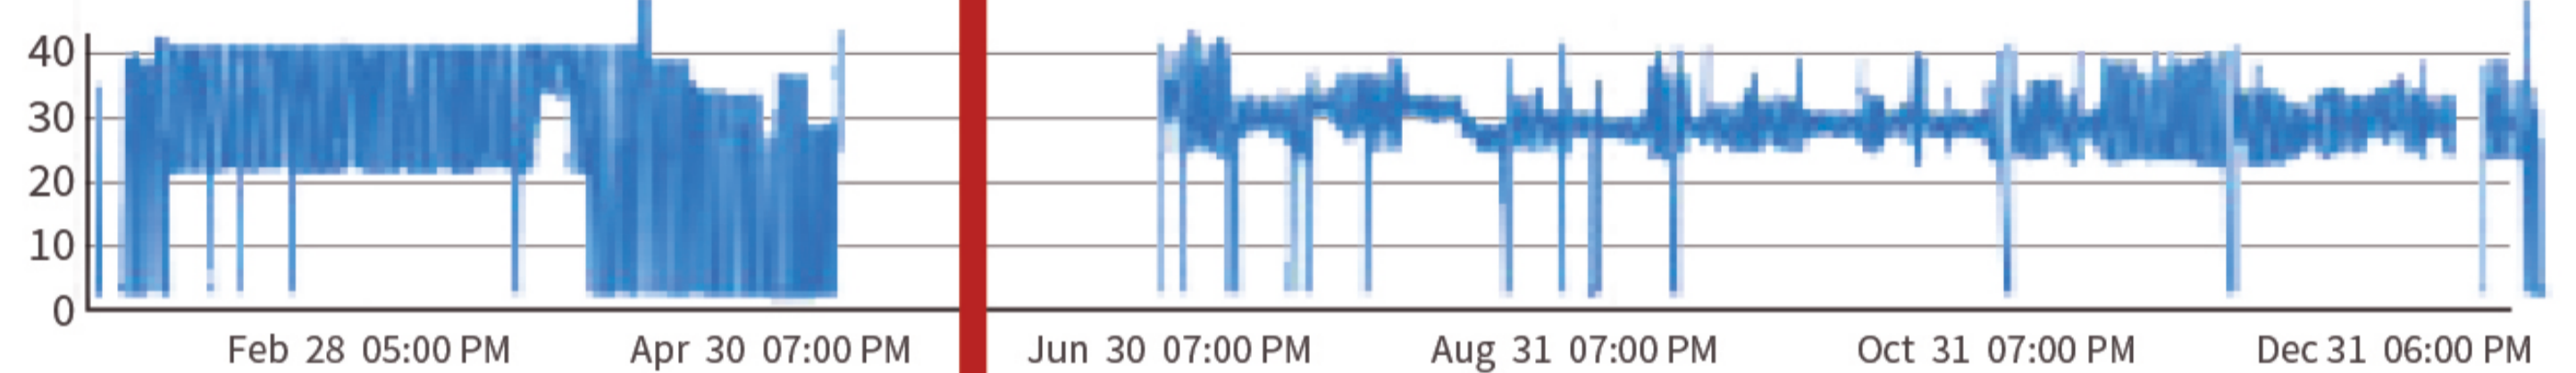
Motor Current

27.9 4:01 pm
amps

∨ 0.0 ∨ 44.1 ∨ 44.1 ∨ 24.2

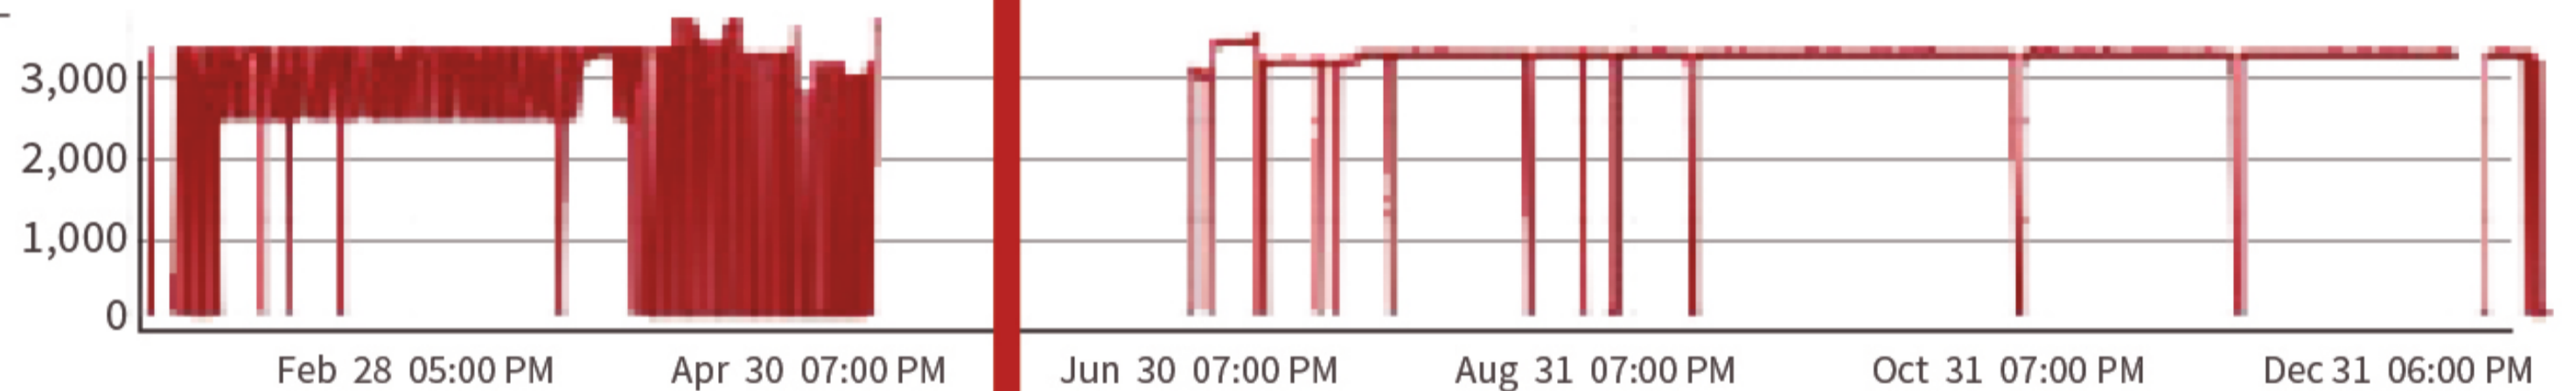
Motor Voltage

2,707 4:01 pm
volts

∨ 0 ∨ 3,028 ∨ 3,028 ∨ 2,221

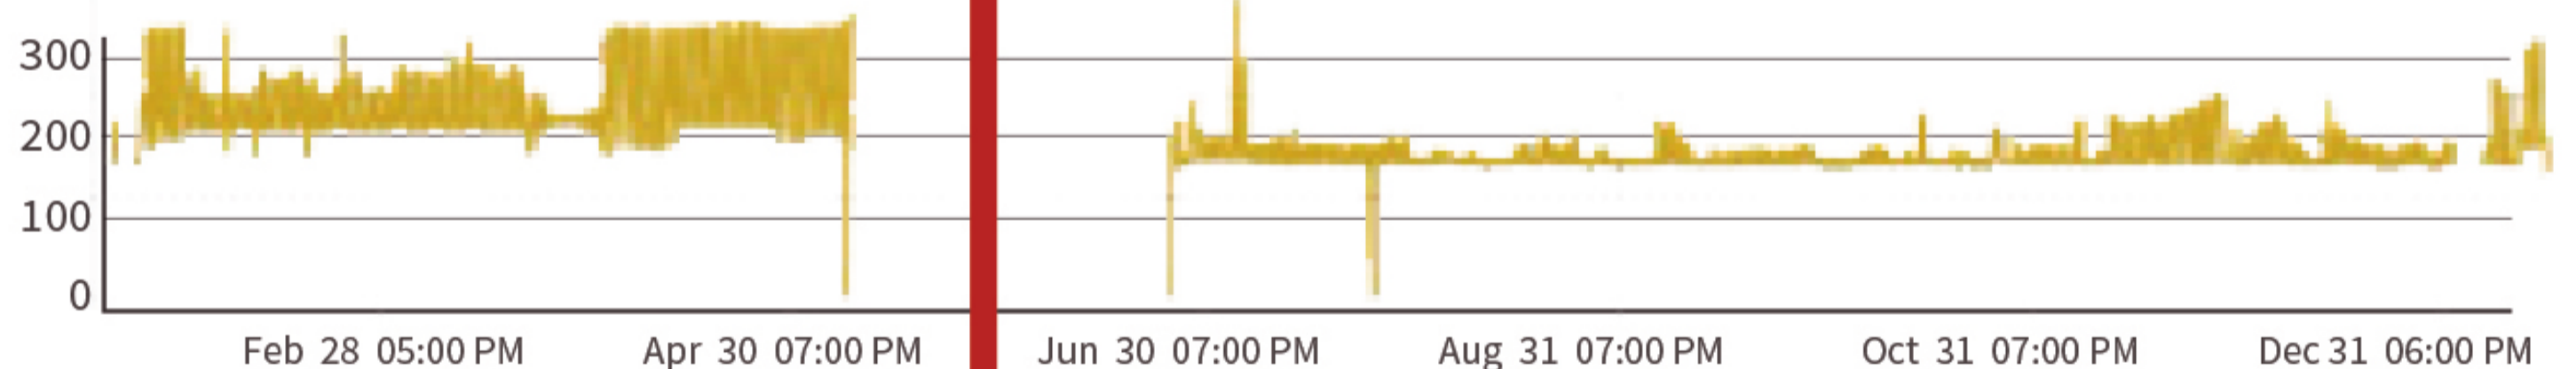
Motor Temperature

136.0 4:01 pm
F

∨ 0.0 ∨ 292.6 ∨ 292.6 ∨ 174.2

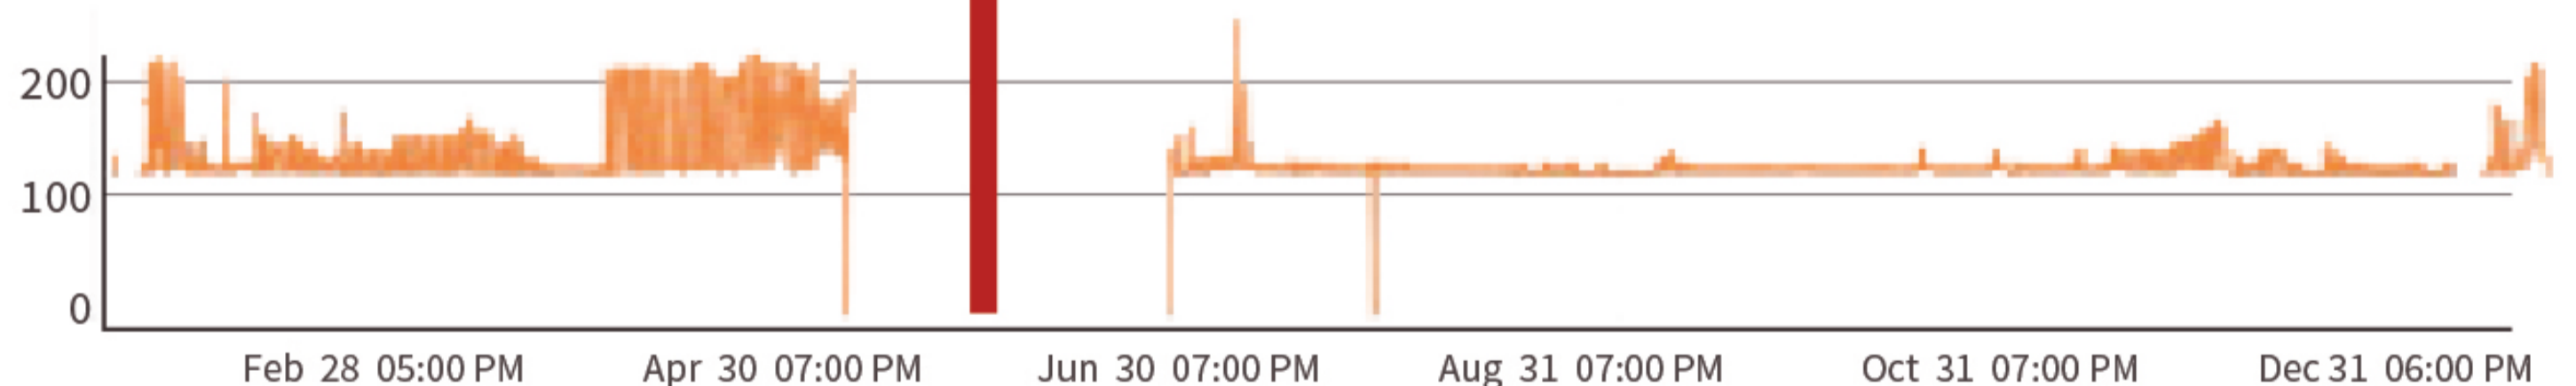
Fluid Temperature

135.0 4:01 pm
F

∨ 0.0 ∨ 274.8 ∨ 274.8 ∨ 147.1
